# Hotel + Leisure case studies

## Midland Hotel Manchester

Roof area: 1,800m<sup>2</sup>

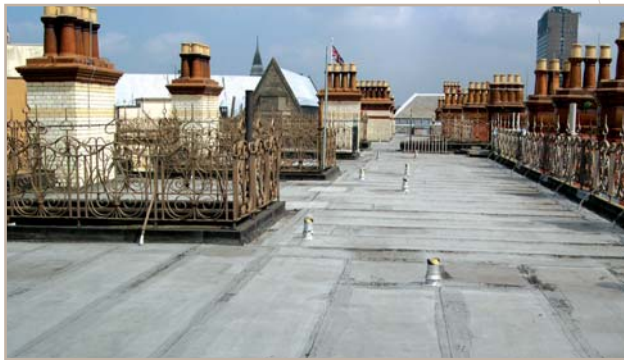
Before

Following a visual survey and core sample analysis of the flat roofing, a thermographic survey was carried out to identify areas of saturated cork insulation, of which 200m<sup>2</sup> was found. As a result, it was decided that the most cost effective method of re-waterproofing was to replace the wet insulation and then overlay the entire roof allowing the client to retain the other 1,600m<sup>2</sup> of insulation.

A combination of reinforced bitumen roofing membranes on the flat areas and liquid coatings for the complex detailing was used and a manufacturer's guarantee issued to cover both systems.

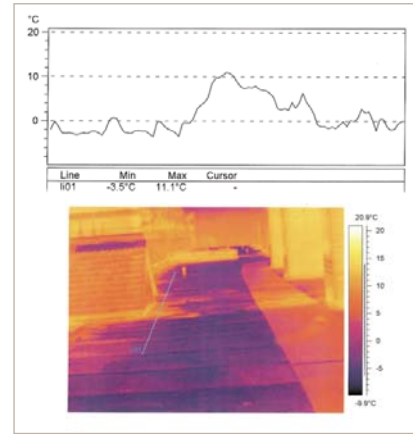
Thermographic image and data results
